Lake Britton Bridges Project Description

June 7, 2017

For the environmental analysis to rehabilitate
two former railroad bridges along the Great Shasta Rail Trail,
located at Lake Britton in Shasta County, California

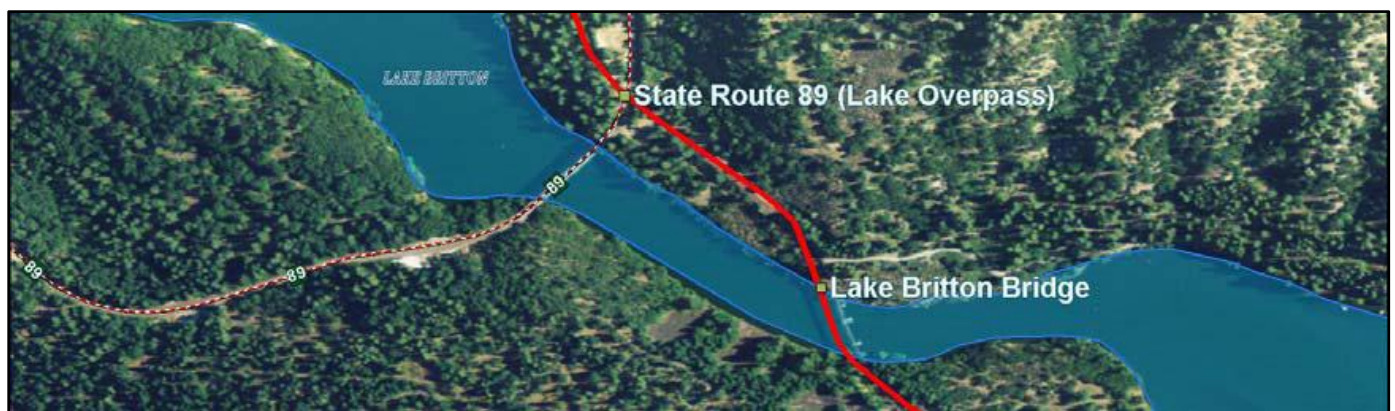
All seven GSRT bridges are structurally deficient and in need of repair or replacement to provide safe public access. Two major bridges are the Lake Britton Trestle and the Highway 89 Overpass (Lake Overpass) near Dusty Campground and Jamo Point day use area (see photo below). Until these bridges are rehabilitated, there is no alternative access for trail users to continue their journey on a through trail between the Burney and McCloud. Both bridges were inspected by a civil engineer in 2014. Final inspection reports with various alternatives to rehabilitate each bridge and cost estimates were completed in March 2015.

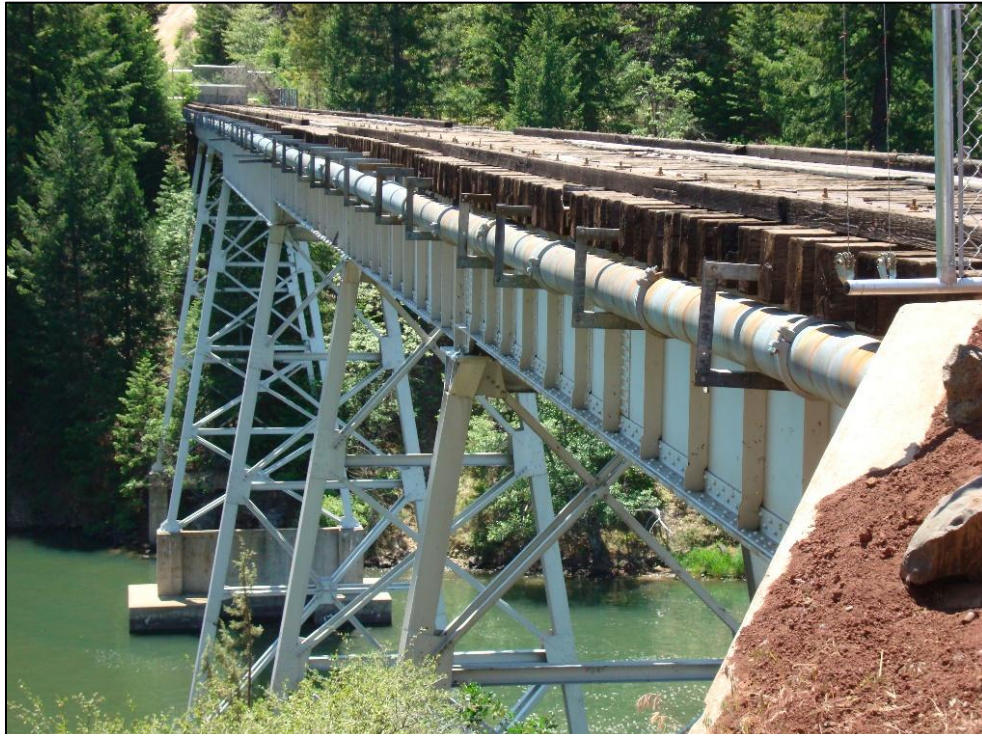
Lake Britton Trestle, 462 feet long with six steel towers and 60 to 95 feet above the water depending on pool height.

This impressive bridge is a 462 foot span, open timber deck, steel girder trestle, built in 1955. It stands 60 to 95 feet above Lake Britton depending on pool height. The steel girder trestle has six towers or bents resting on concrete piers/pile caps, which in turn rest on driven steel pipe/concrete piles. The structural live load design was for a Cooper E50 (railroad rating). When rehabilitated, the design load for this bridge will be lowered to a loading appropriate for planned public use and support maintenance vehicles crossing and working on the bridge.

The six steel towers also show surface corrosion and those areas will be cleaned and repainted. Tower #4 in the center of the trestle has serious structural degradation. The west anchor bolt/plate connection shows stress cracking and rivet loosening, which can be repaired with welding and recoating. The concrete pier/pile caps upon which the towers rest have varying levels of deterioration such as distress cracking, moisture intrusion, and spalling. The abutments also show deterioration. Crack and void filling is recommended with sand blasting of surface deterioration. A protective sealant is proposed for concrete surfaces. The underwater inspection of the piles revealed no structural problems. However, the engineer recommended the larger tree limbs and debris be removed from around some piles. A geotechnical inspection did not find any needed bridge rehabilitation related to geology and soils. The installation of an underdeck catwalk/railing system has been recommended to allow inspection and maintenance work to be done on the steel structural members hidden by the deck structure.

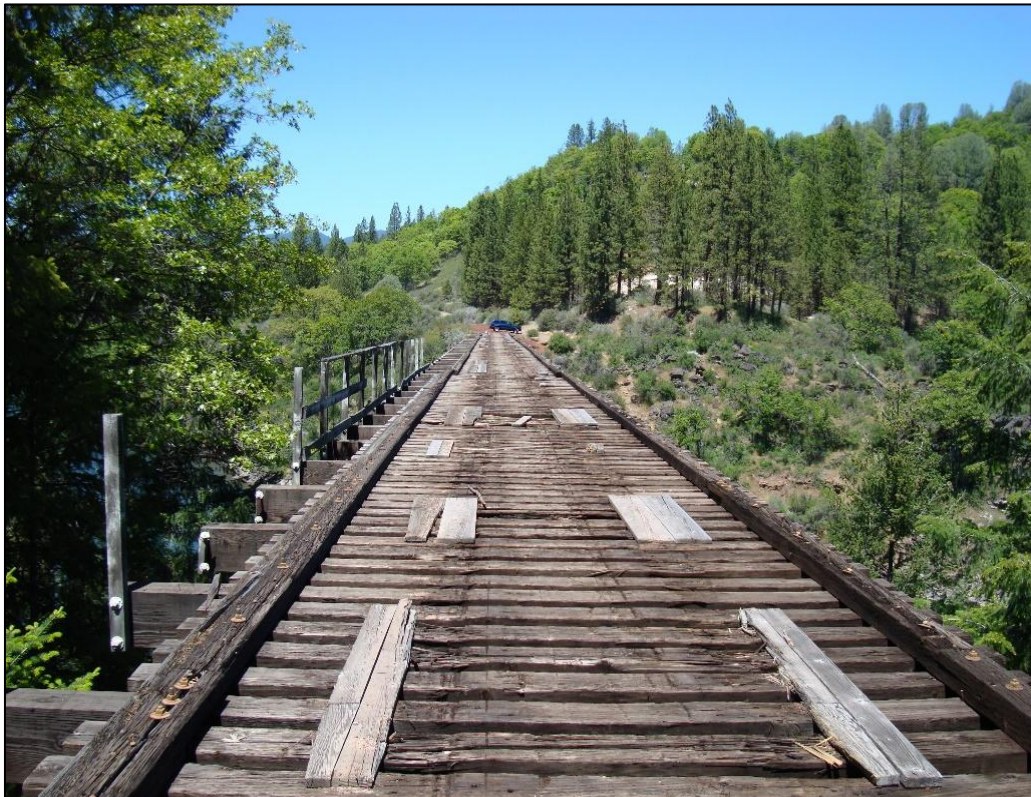
Lake Britton Trestle deck ties and curb.

The wooden timber deck, ties and curb system exhibit advance deterioration. The original timber walkway and guardrail have failed. The timber deck needs to be replaced and safety hand rails installed. The steel girders and cross bracing under the wooden deck have some surface rust, which will be cleaned and those areas repainted. A large steel conduit carrying fiber optic communication lines will need repairs to the support system.

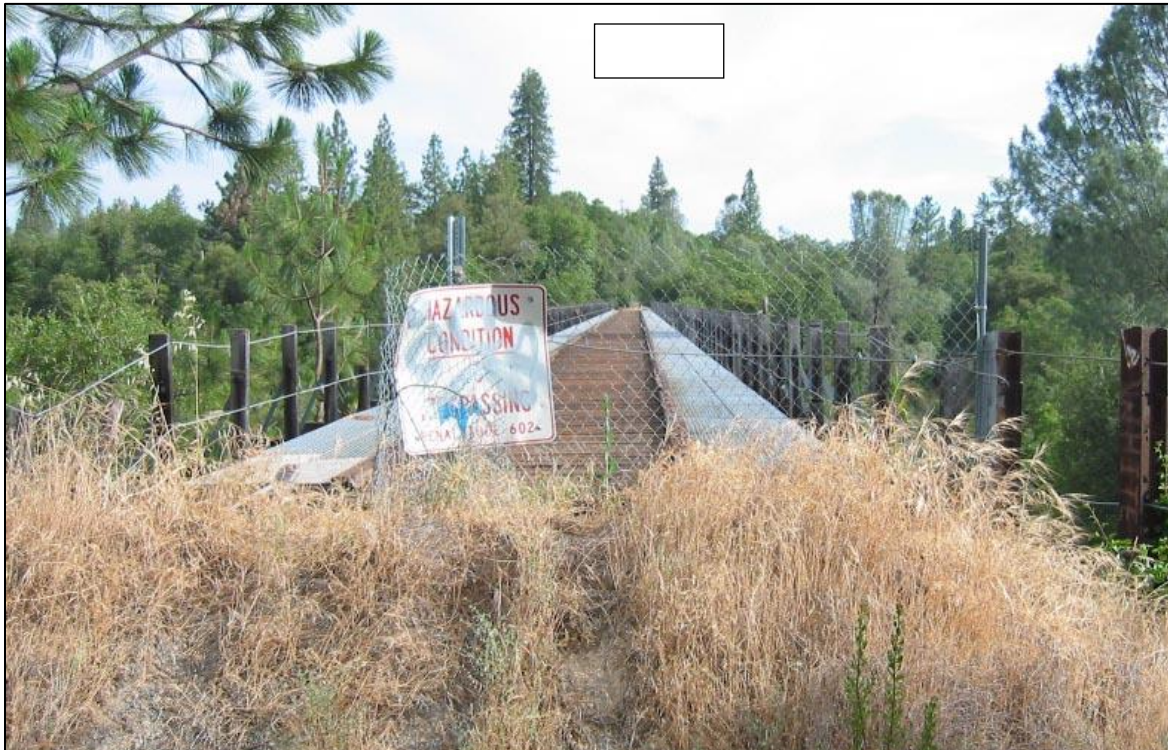
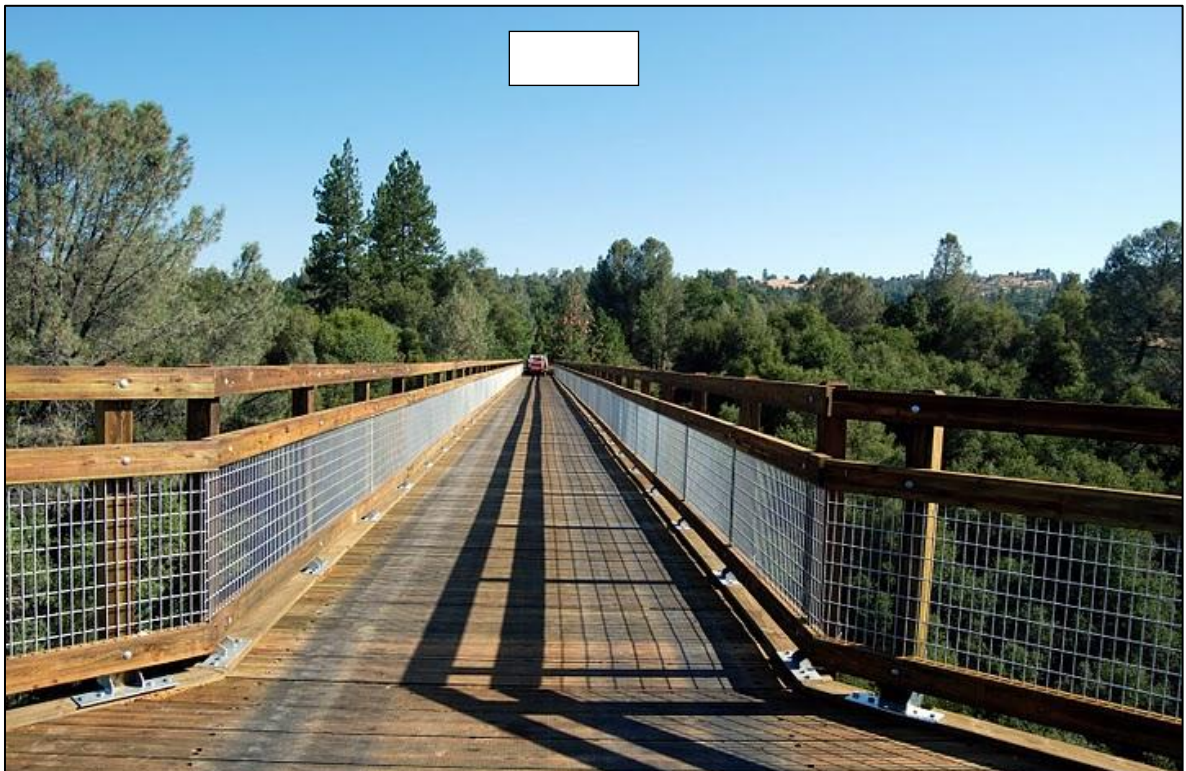
Before and after photos of the rehabilitation of the 1903 Weber Creek Trestle on the 36-mile El Dorado Trail, Placerville, CA. This trestle is 620 feet long with 8 steel towers, 100 feet above the creek. General design elements for the Lake Britton Trestle will be similar.

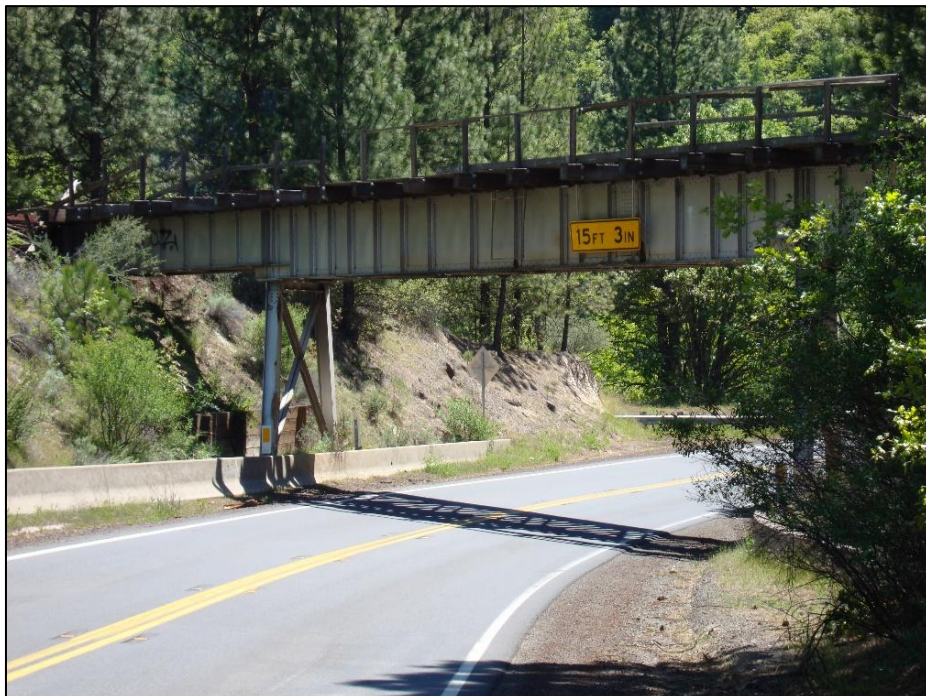
Lake Overpass, 117 feet long and 15 feet, 3 inch clearance over State Route 89 near Jamo Point

The Lake Overpass is a 117 foot span, open timber deck steel trestle bridge over Highway 89, just north of Lake Britton. It was originally designed in 1954 and constructed at the same time as the Lake Britton Trestle. When rehabilitated, the design load will be lowered from a Cooper E50 (railroad rating) to a loading appropriate for the planned use at this bridge location. The timber deck, tie and curb system on this bridge exhibits advanced deterioration. The original timber walkway and guardrail have also failed. The deck will be replaced and safety handrails will be installed. There are three major areas of damage to the structural girders from vehicle hits. In some locations, the bottom flanges and plates of the girders are bent and deformed with some tears and shearing at the outer edge. There are also bent/deformed vertical braces, diagonal braces and gusset plates at these areas. Areas that have damage from vehicle hits will be repaired as needed to meet final design loading and structure protection. Some peeling paint and corrosion on the steel surface was noted and will be cleaned and those areas repainted.

There are two steel towers or bents at either end of the bridge. They have some peeling paint and surface corrosion that needs to be cleaned and those areas repainted. Dents from vehicle hits were noted. The concrete abutments have slight cracking at the anchor bolts, but otherwise are in fairly good shape. Cracks will be filled and concrete surfaces cleaned and sealed. The wood retaining walls at both sides of the bridge next to the towers will be replaced and the ground stabilized.

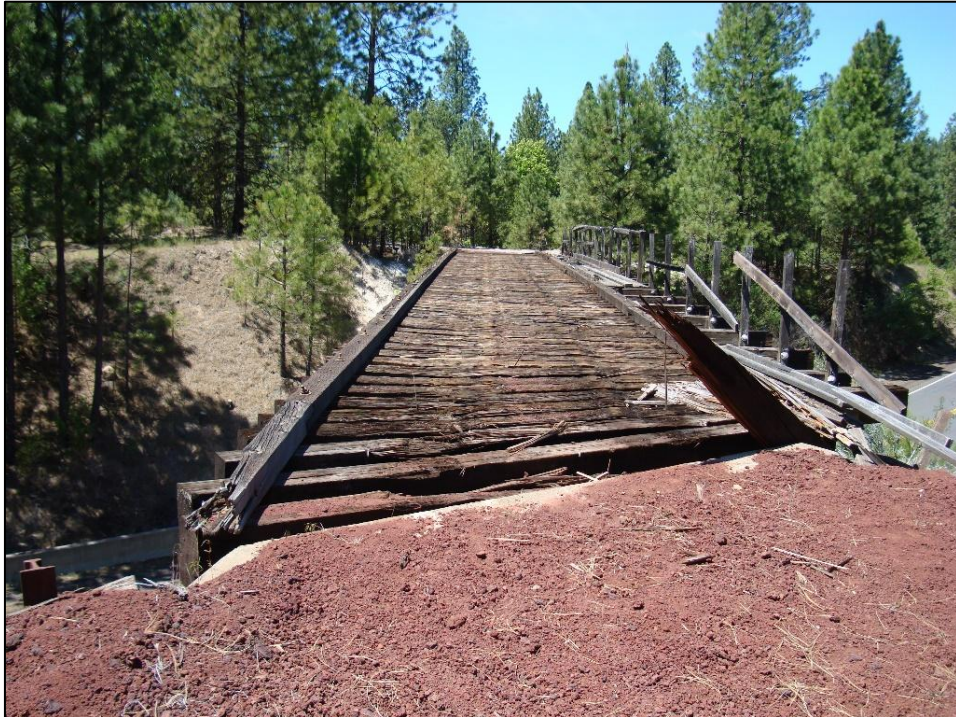
Highway 89 Lake Overpass deck ties and curb

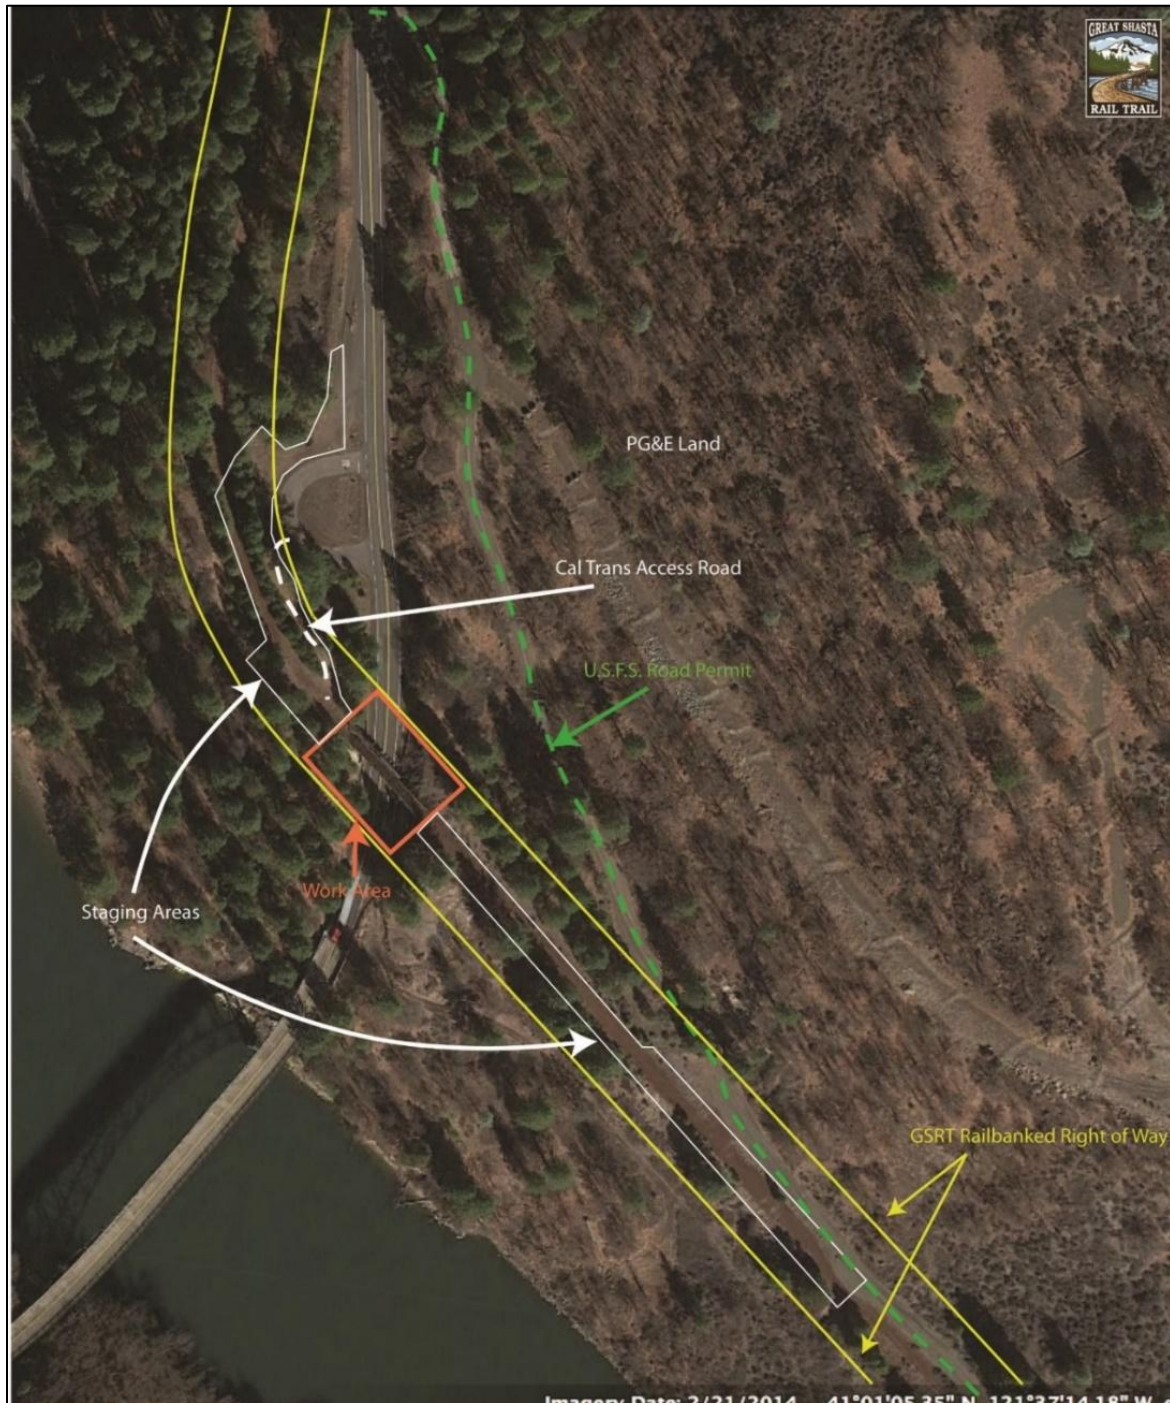
Exhibit 2: Lake Overpass – GSRT Milepost 49.899 and Caltrans 89SHA PM 29.33

The area of potential effect for the environmental analysis is the overpass, including deck, girders, towers, retaining walls and an area extending the length of the overpass and 75 feet wide from both sides of the abutments. One temporary staging area is proposed on the southeast side of the overpass (off the Dusty Campground access road). Another temporary staging area is proposed on the northwest side of the overpass, four tenths of a mile south of the Lake Britton Ramp Road (Jamo Point) both within the right-of-way across PG&E land (see Exhibit 2 on the next page).
